## TREATMENTS OVER TWENTY YEARS: A CRITICAL ASSESSMENT OF FOUR INTERVENTIONS UNDERTAKEN SINCE 1991

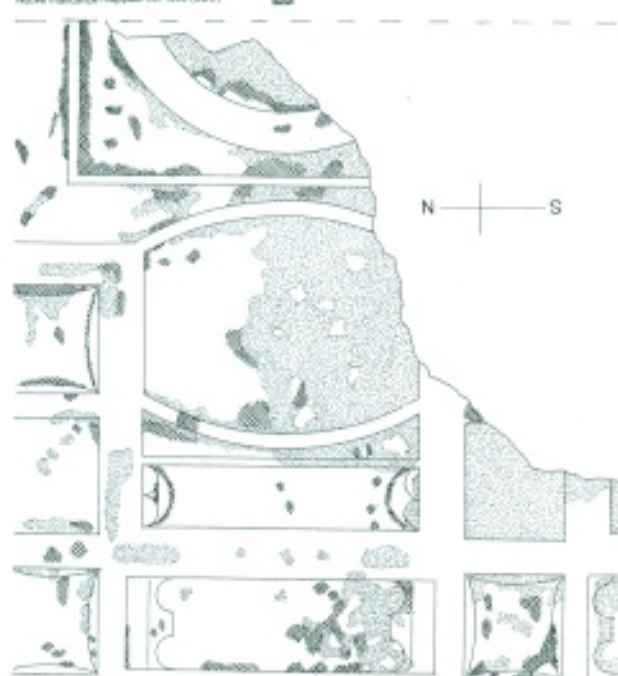
[1] Domus Aurea. A map of part of the Vault, the light grey showing losses in 1983 and the dark grey further losses occurring in just the 15 years to the treatment in 1998-99.

The decorated plasters and underlying intonacos of the Sala della Volta Dorata were in critical condition at the time of the treatment: there were sections of plaster detached by centimetres from the underlying arriccio, large areas of the vault were covered in sulphate efflorescence and much of the final intonachino was partially or totally detached – indeed thanks to a detailed documentation of part of the vault carried out in 1983<sup>9</sup> we were able to determine 15% of the surviving intonachino had been lost in just 16 years.

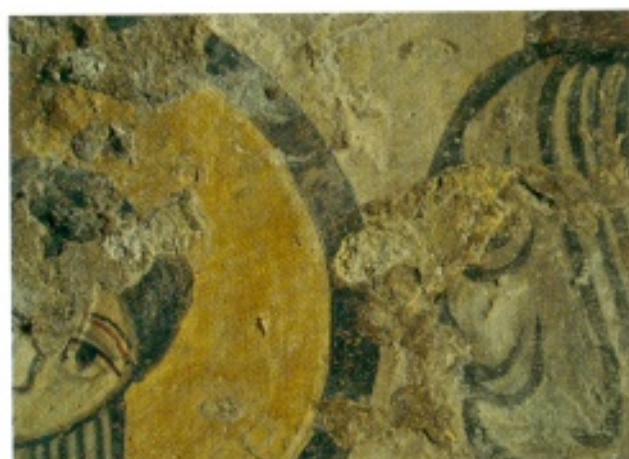
[2] Church of the Original Sin, Matera. Carbonate efflorescence around the edges of the fills added during restoration.

The fillings themselves presented more significant problems. In some cases, probably due to their greater porosity compare to the surrounding plaster, they had been subject to localised colonisation by microorganisms, being covered with a green bio-film, with the potential risk of these microorganisms spreading to the surrounding original painted surfaces. In other cases, and more dangerously, an impermeable lime film had formed over the surface of the fillings and the surrounding original plaster was being put at risk by carbonate efflorescence around the edges of the fills.

These problems were resolved by an even more minimal intervention: the fills and retouching were removed.

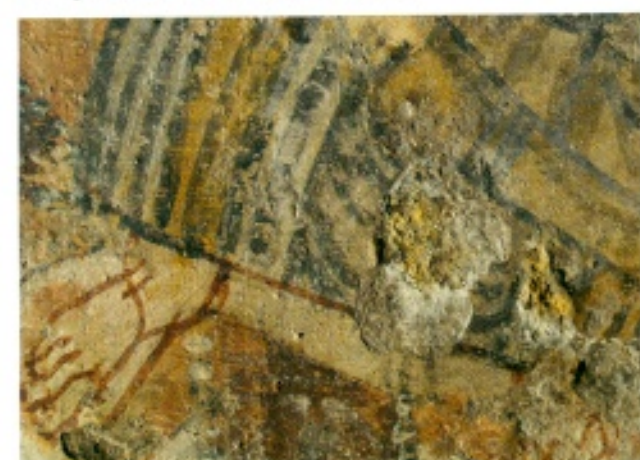
[3] Church of the Original Sin, Matera. Carbonate efflorescence around the edges of the fills added during restoration.

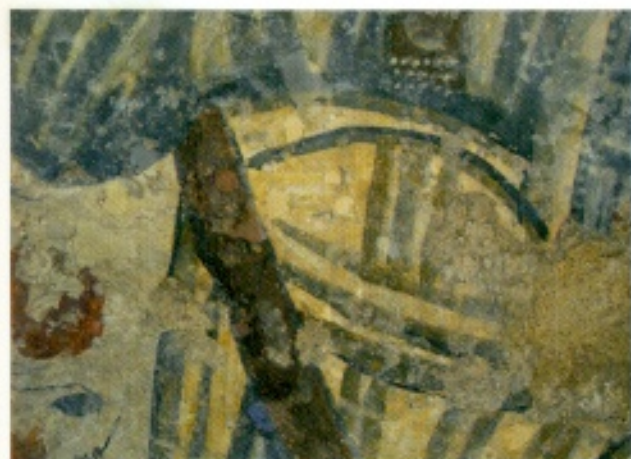
[4] Church of the Original Sin, Matera. Water colour retouching has faded extensively on lime/sand fills added during restoration.

Despite the fact the pigments should have been stable, in many cases they had faded significantly.

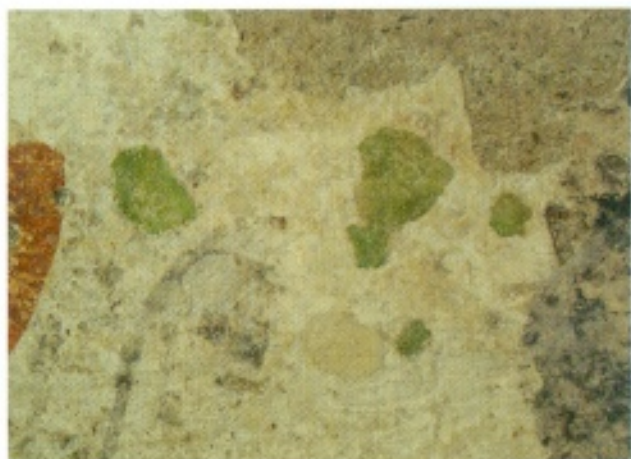
[5] Church of the Original Sin, Matera. The fills added during restoration have stimulated growth of green microorganisms.

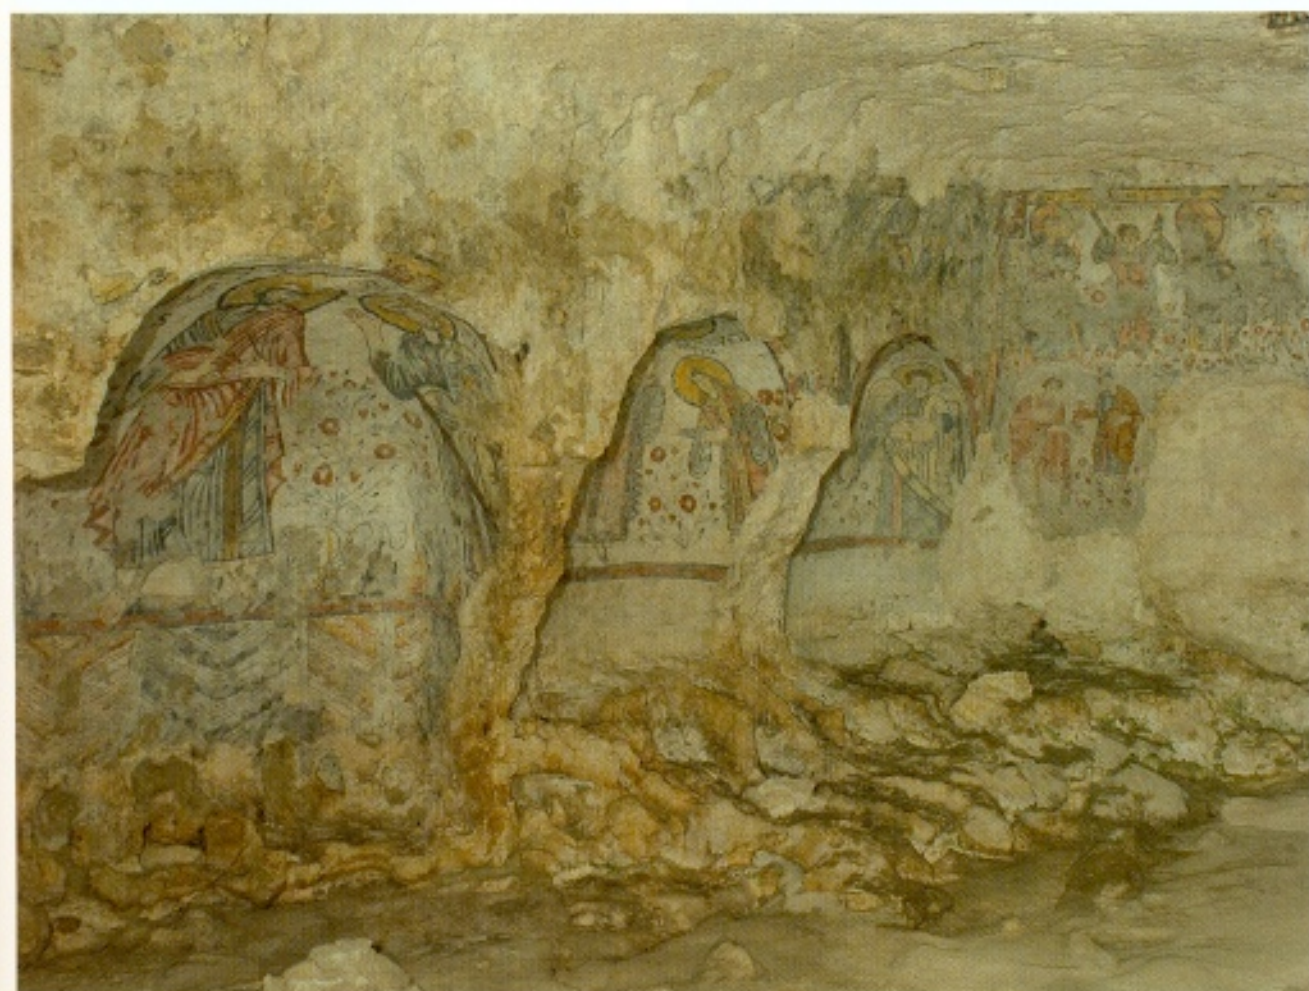
[6] Church of the Original Sin, Matera. End wall of church prior to maintenance treatment in 2010.

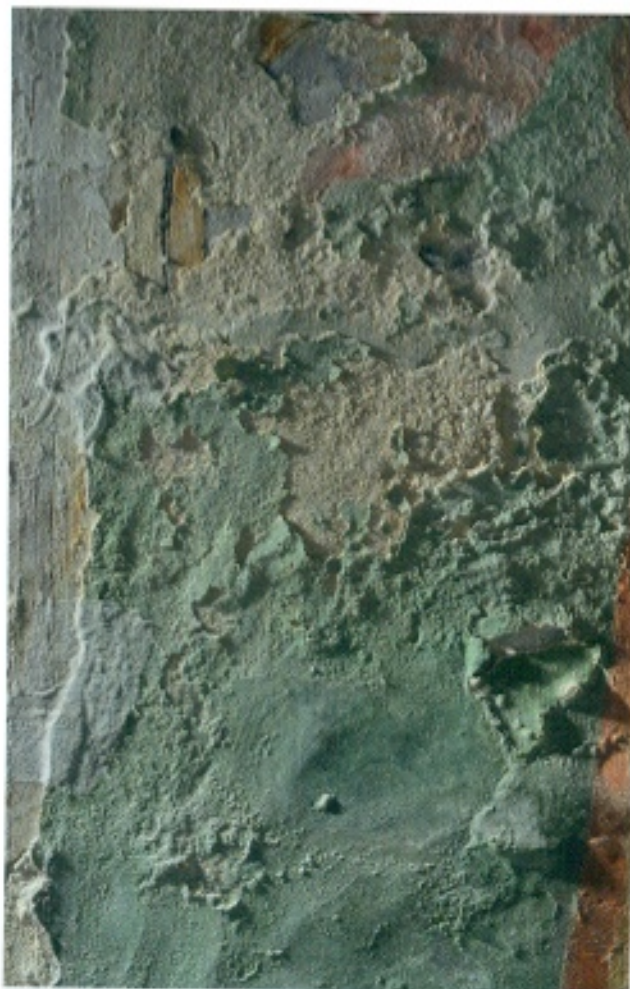
[7] Sanctuary of the Madonna, Paganica. Severe powdering of plaster and detachment of paint film. The paint layer here is heavily contaminated with synthetic resin.

This treatment was carried out as part of an emergency stabilisation treatment carried out on the chapel which had been slightly damaged in the earthquake of 2009. As mentioned previously, the chapel is built against a rock cliff, and on the plaster covering the rock face is an eighteenth century Madonna and Child painted over fragments of an earlier work now lost. The current painting had suffered severe damage from sulphate salt efflorescence in several areas, areas which were also in part heavily contaminated with films of an unknown synthetic resin applied in a treatment carried out in 1991.

Given the extreme state of degradation of the paint and plasters, and given the limited and slow acting adhesive characteristics of the inorganic consolidants available, it was decided to firstly remove the sulphate salts

using anionic ion-exchange resins and then apply an organic adhesive in low concentrations until the paint layer was stabilised.<sup>12</sup> In this case, to ensure the survival of the degraded materials, the aspect of physical and chemical compatibility of the consolidant had to be subordinated to other characteristics of the adhesives being considered – the ability to provide temporary stability

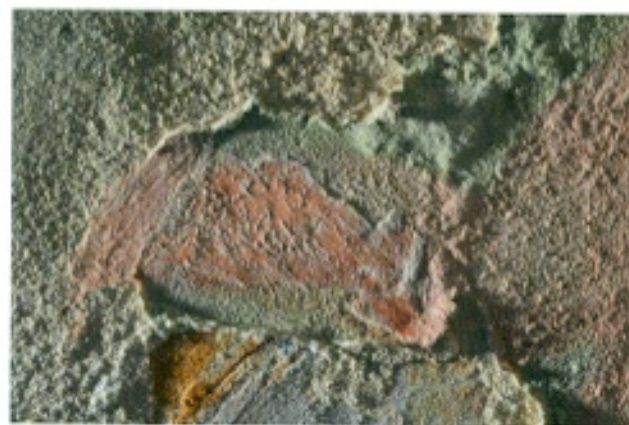
[8] Sanctuary of the Madonna, Paganica. A detail showing the severe powdering of plaster. The surviving paint layer here is so totally impregnated with synthetic resins that it has been completely denatured.

In the damaged areas was a mixture of powdered pigment and intonaco with tiny fragments of paint flakes in a layer several millimetres in thickness. Here the large quantities of synthetic resin precluded a treatment using barium hydroxide. Attempts to treat the massive decohesion with nanoparticles of lime applied through Japanese paper were hindered by the low surface tension of the alcohol vehicle for the lime nanoparticles, and the lack of immediate adhesion of the lime: no matter how carefully the materials were applied and removed, the powdered paint and plaster would either preferentially adhere to the Japanese paper or simply fall off the wall.

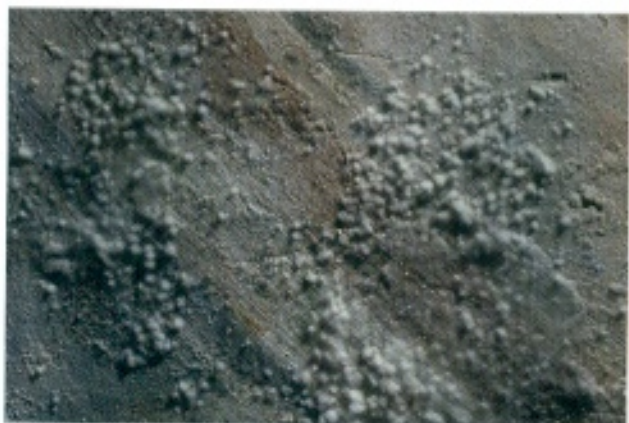
[9] Sanctuary of the Madonna, Paganica. A detail showing fungi growing on the paint layer.

The only remedial solution to such attacks was unfortunately the periodic treatment of the surfaces with biocide agents,<sup>4</sup> forced ventilation being potentially dangerous as it could lead to salt crystallisation.

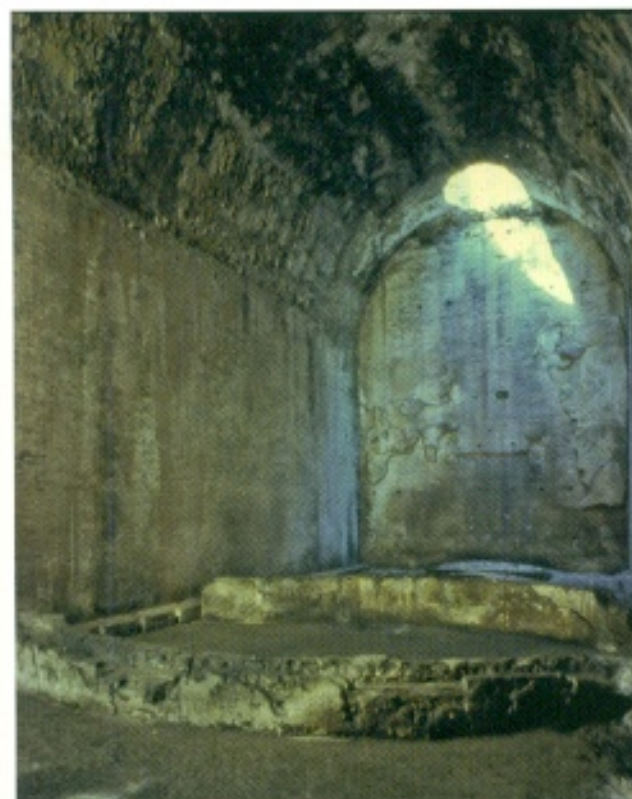
[10] Domus Aurea, Rome. A general view showing the catastrophic environmental conditions which prevailed in the 1990s.

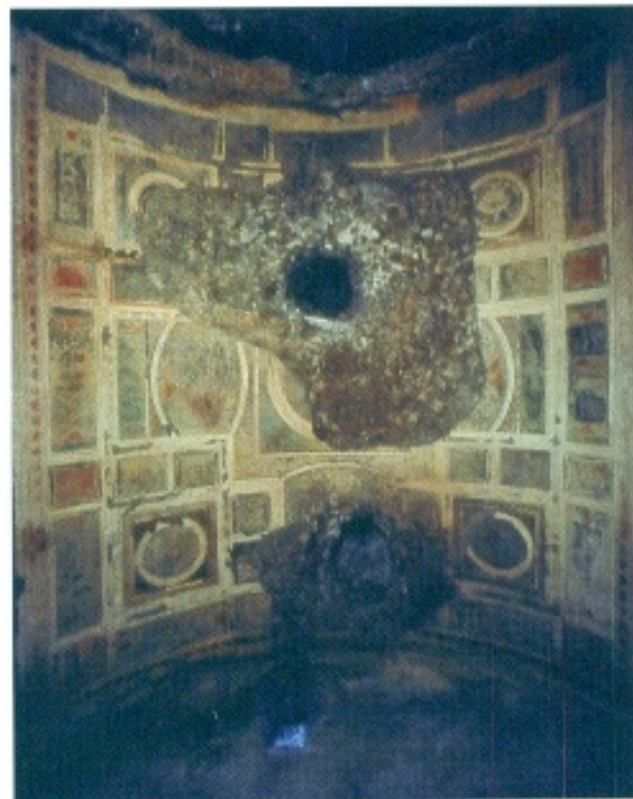
[11] Domus Aurea, Rome. General view of the vault after treatment

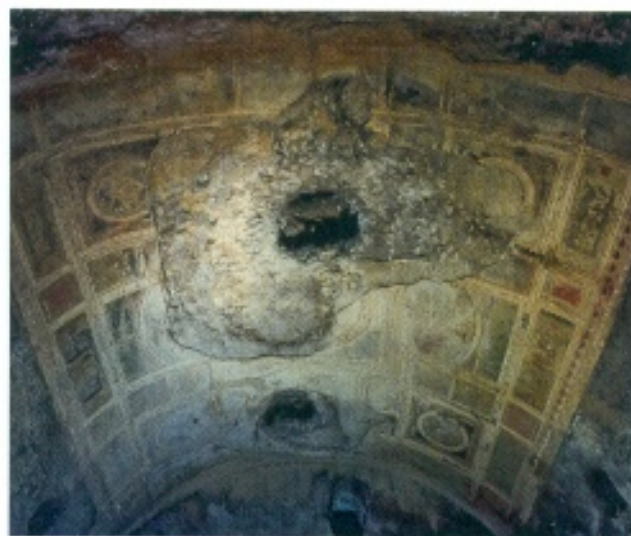
[12] Domus Aurea, Rome. General view of the vault before treatment. The white areas are sulphate incrustations of up to 5 mm in thickness.

Another problem to be faced was the widespread and highly visible sulphate efflorescence on the vaults. However, detailed examination and analyses of cross-sections established that the salt crystallization was principally located on the surface of the plaster with limited subflorescence within the intonaco, and consequently, the plasters were suffering from only mild decohesion. It was decided to try the ammonium carbonate/barium hydroxide method for sulphate removal and passivation, and plaster/paint consolidation.

Following the criterion of minimally invasive treatment it was therefore decided to proceed solely with ammonium carbonate poulticing of the sulphated areas and not to employ the barium hydroxide treatment.

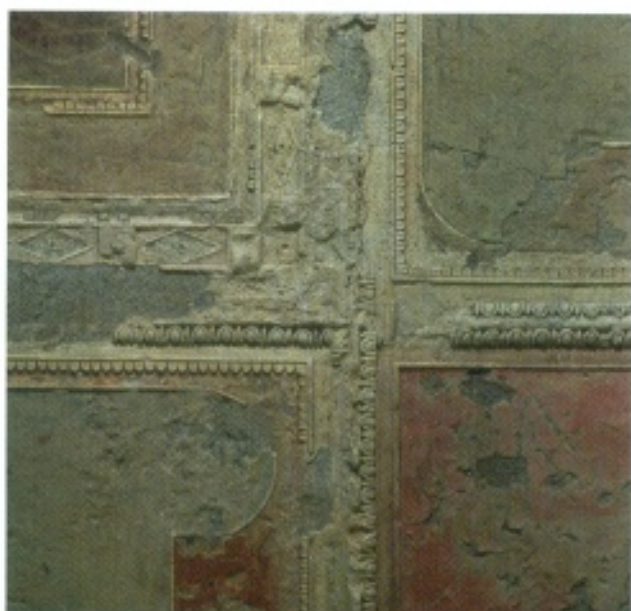
[13] Domus Aurea, Rome. Detail showing extent of losses in the stucco decoration and the thin, painted intonachino layer.

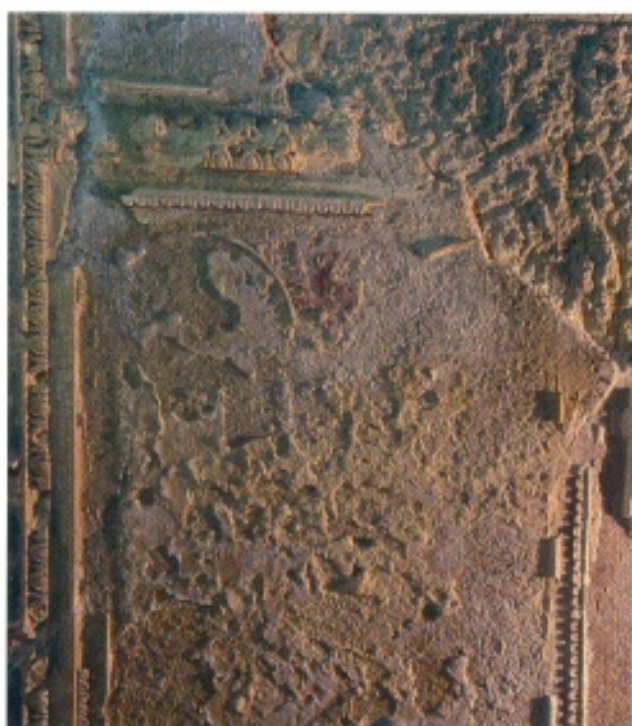
[14] Domus Aurea, Rome. Raked light, showing salts and the detachment and cupping of the thin, painted intonachino layer.

Small detachments of the intonaco and intonachino were filled with micro-injections of diluted hydraulic

grouts, and where the intonachino was in danger of detaching, its borders were lined and reinforced with fine lime putty/sand mortars.

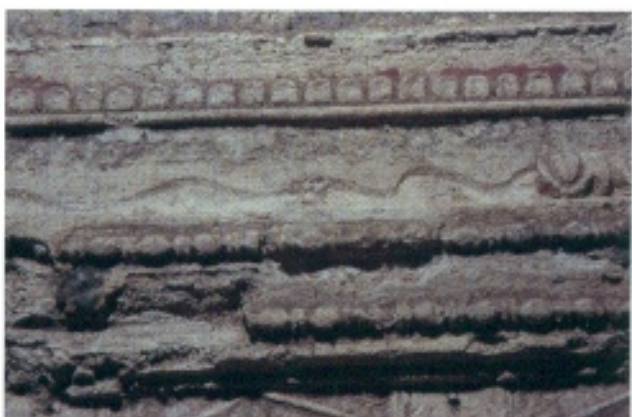
[15] Domus Aurea, Rome. Detail showing losses and powdering in the stucco decoration.

Successively, in some areas the stucco decoration was found to be still slightly decohesed. Rather than subjecting the fragile material to further treatment of wetting and poulticing and rinsing, it was decided to once again implement a treatment previously employed in the Sala della Volta Dorata. In the late 1970s a part of the surface of the vault had been treated with Paraloid B72 as part of a test consolidation. In the intervening 20 years this treatment had provoked no discernible side effects. Consequently, on the principal of not introducing new materials, but rather re-employing successful methods, and reluctant to subject fragile stuccos to the cycles of poulticing, the stuccos were treated with low concentrations of Paraloid B72 dissolved in acetone (4%) and applied, as in the previous case study in the crypt of the cathedral in Anagni, only where necessary and only reapplied if the first treatment was not adequate.

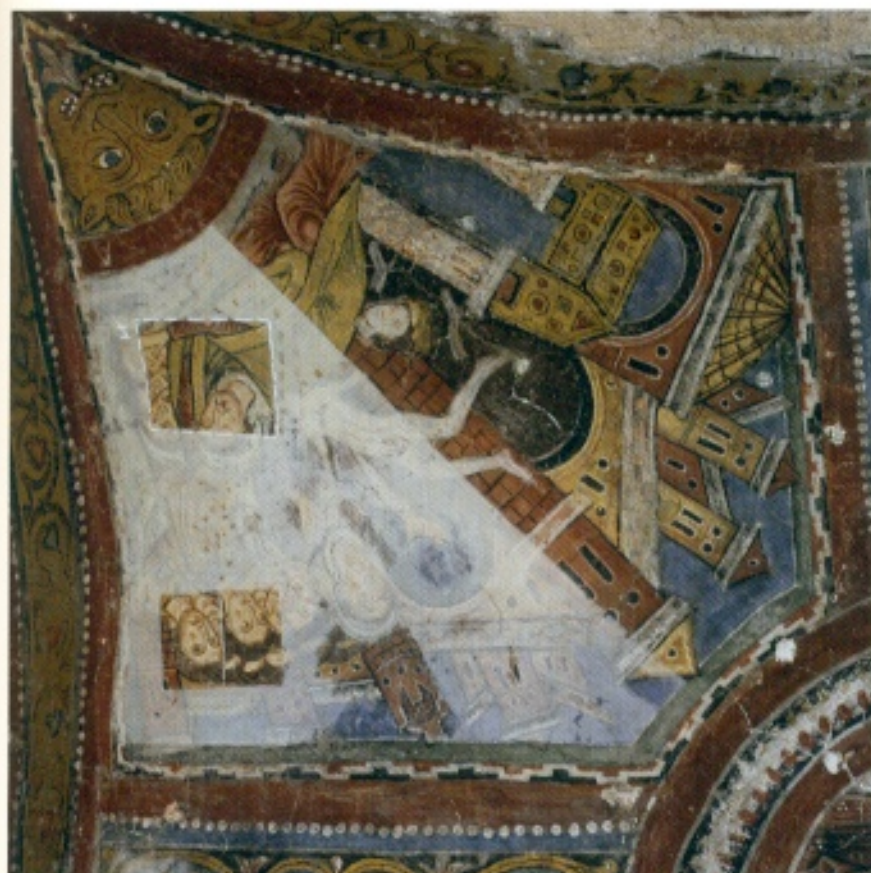
[16] Anagni Cathedral, Crypt. Part of the vault during cleaning

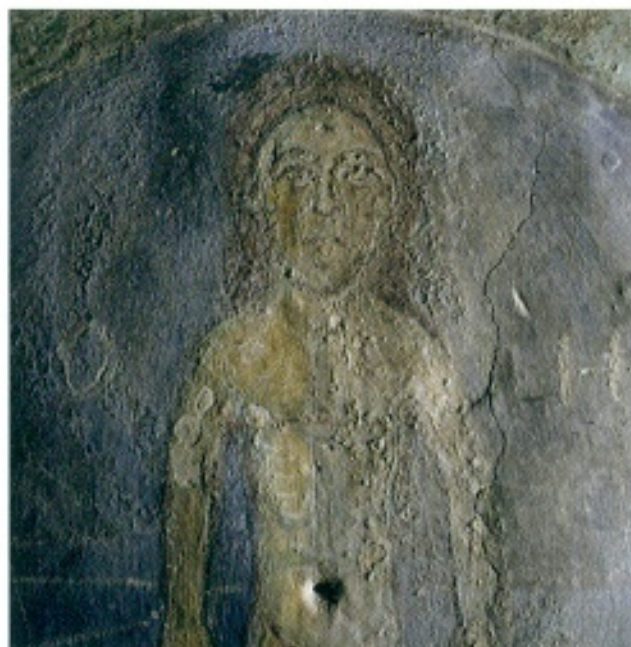
[17] Anagni Cathedral, Crypt. Flaking paint on a figure in raked light

treated using a material commonly employed at the time (early 1990s) and in the Rome area the acrylic resin in emulsion Primal AC33. However, due to obvious concerns over the creation of barrier films which would block water vapour, the adhesive was applied at very low concentrations (1.5% vol/vol in water/alcohol), left to cure, then reapplied only where the previous treatment had been insufficient.<sup>8</sup> Several follow up maintenance treatments (1997, 2001, 2008) verified that the treatment was effective and had not created problems.

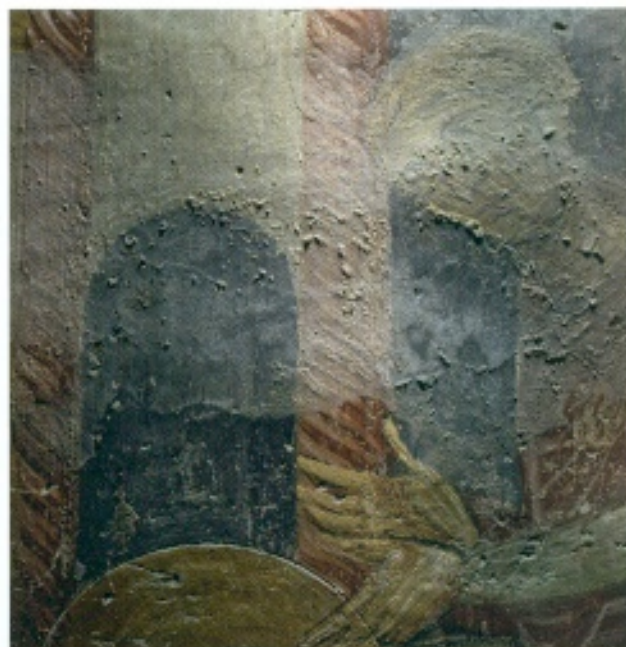
[18] Anagni Cathedral, Crypt. Salt efflorescence, fortunately limited and flaking paint

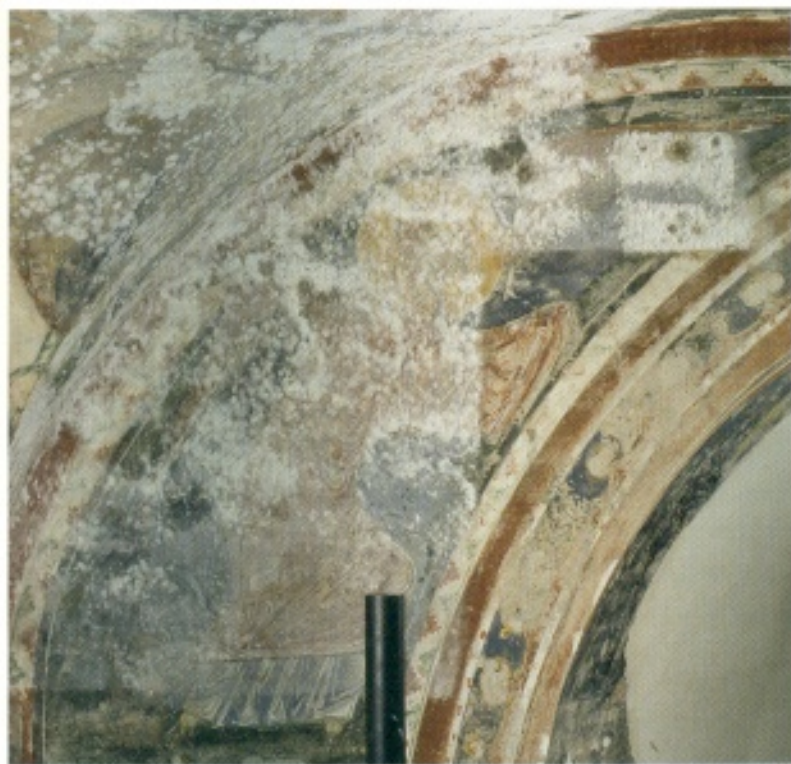
In three of the four sites under examination (Anagni, the Volta Dorata, Madonna dell'Appari), prior to the start of the treatment the sites displayed low level microbiological infestation, with limited traces of fungi and/or algae. Several weeks or months after the start of the restoration, in all three cases there was an explosive growth of micro-organisms, principally fungi.

[19] Anagni Cathedral, Crypt. Microbiological infestation of fungi on the paint layer

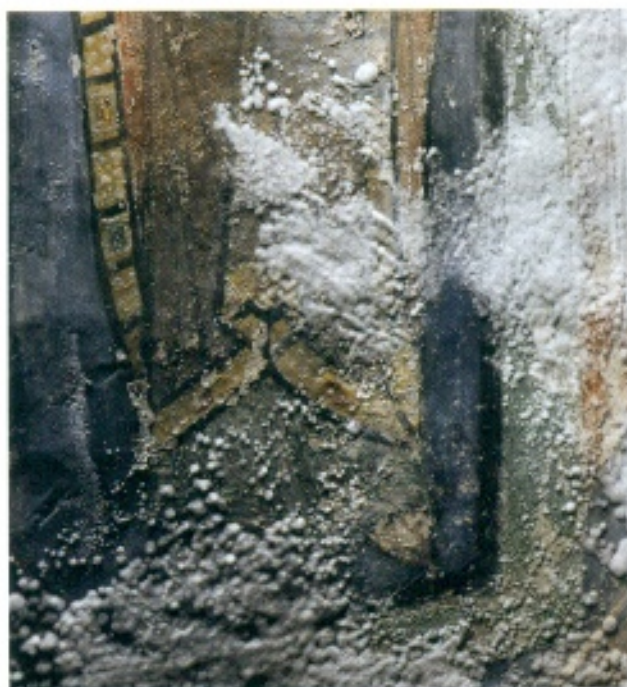
[20] Anagni Cathedral, Crypt. Detail of microbiological infestation of fungi on the paint layer
