# Reconstruction and Remounting Materials and Techniques of the Wall Paintings in the Tablinum of the House of the Bicentenary

Mark Gittins, Maria Luigia Bonaschi, Francesca Piqué, and Leslie Rainer

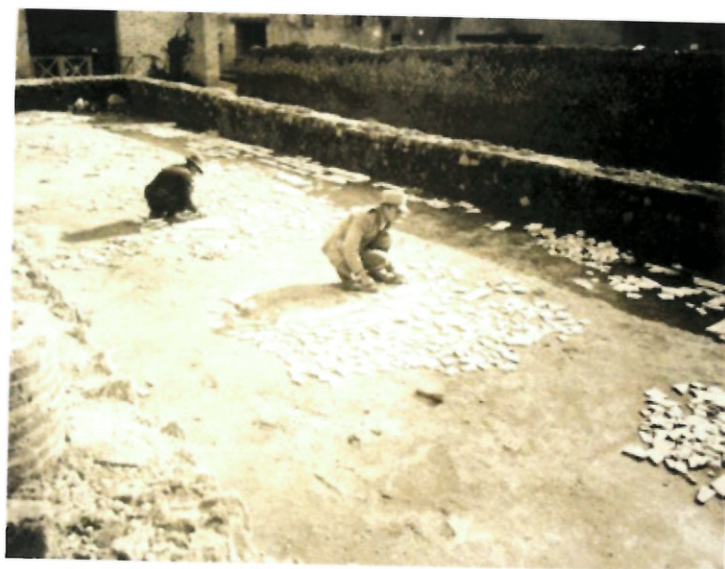
FIGURE 2.1.

Reassembly of fragments at the site of Herculaneum, 1935. (Historical Archives of the Soprintendenza Pompei, Maiuri, inv. C2649)

Although it is clear that this can be considered by no means an accurate quantitative evaluation of treatment processes carried out on the paintings, perhaps their relative frequency suggests that the detachment and reattachment of damaged and probably fractured wall paintings may have been more common than the collection, reconstruction, and remounting of fragments collected from the ground. A contemporary photograph from the site shows that fragment collection and reconstruction was part of standard working practice (fig. 2.1).

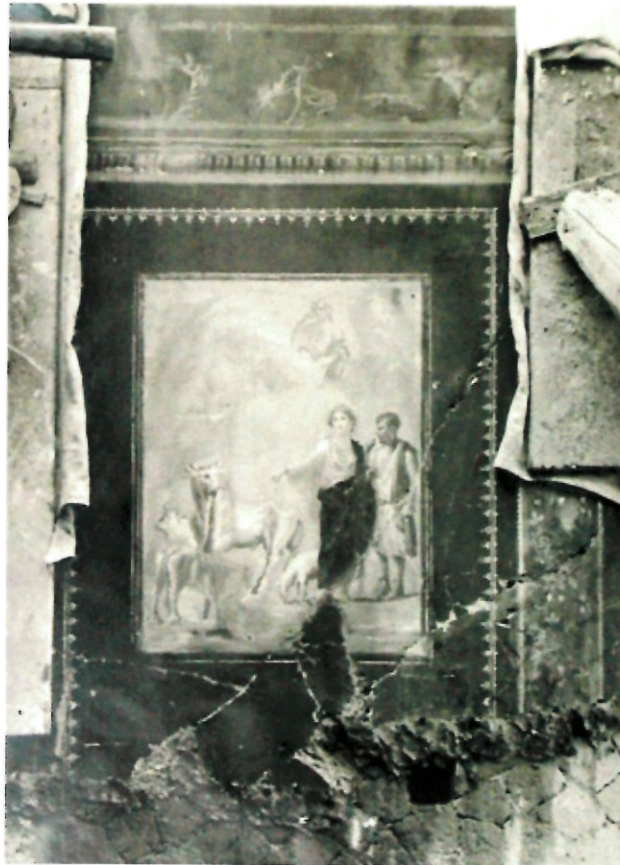
**FIGURE 2.2.**

Photograph of the central section of the west wall during excavation. Wood supports with cushioning material have been placed against the walls and shored up. Temporary rough fills run along the bottom of the plasters to hold them in place.

is made of the remaining scene and medallions—neither when they were found nor in what condition. These entries give an idea of the speed with which the room was excavated and the condition of the wall paintings at the time of excavation. The fact that the east wall medallion and the west wall central rectangular scene were described in such detail upon discovery suggests that perhaps these areas were more or less intact when found, or that this is simply an inconsistency in the recording of the work. The assumption that the west wall central rectangular scene was found still on the wall is further substantiated by the historical photograph from the Soprintendenza Pompei archives of this scene being supported by wood props during excavation and reconstruction (fig. 2.2).

Further evidence can be found in a photo from the excavation (see fig. 2.2) showing the central part of the west wall supported by temporary props, a procedure that, on the basis of other photographs from the archives of the excavation, seems to have been employed when plasters and walls were still standing but considered to be unstable.

There are, however, traces of backing plaster in some of the cracks in the lower plasters shown in this photograph, suggesting that some of these smaller pieces may have been detached and/or reassembled and reattached (see discussion below).

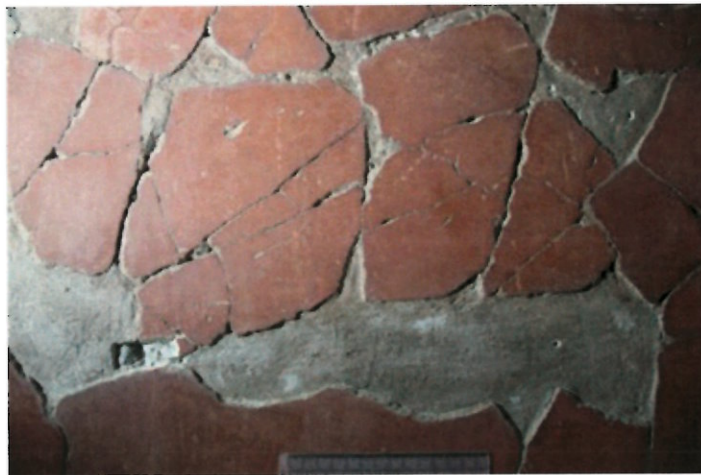
FIGURE 2.3.

Reassembled wall painting fragments, upper west wall. Some pieces lie close together, and the joins between them are not filled; some are farther apart, with restoration mortar applied to fill the gaps.

paintings are composed of numerous fragments, more or less densely clumped together, at times with large lacunae filled with restoration mortar (fig. 2.3).

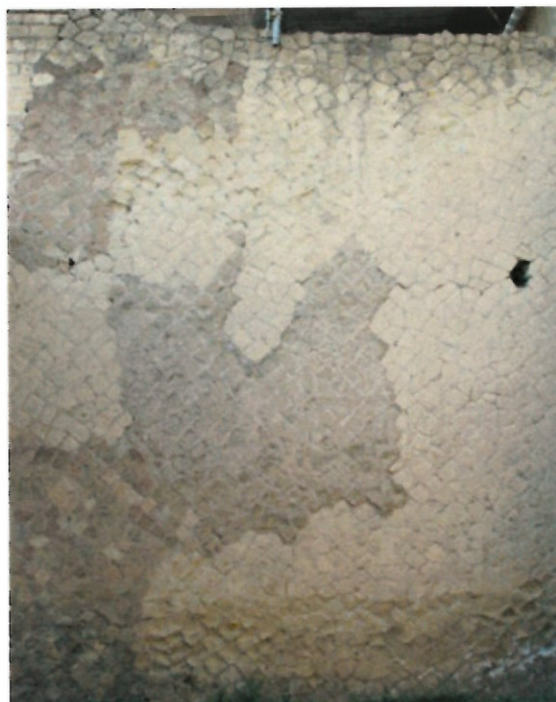
FIGURE 2.4.

Rear of east wall in adjoining ambiente 9. Darker portions at left are original Roman tuff.

It is quite likely that a significant proportion of the underlying tuff wall support of the east wall was replaced, as there are large losses in the original plaster, and most of the surviving plaster has been remounted. Additionally, the other side of the wall, in the adjoining ambiente 9, is largely composed of modern *opus incertum*,<sup>5</sup> though a large area of this wall (ambiente 9) is original Roman tuff constructed in *opus reticulatum* (fig. 2.4).

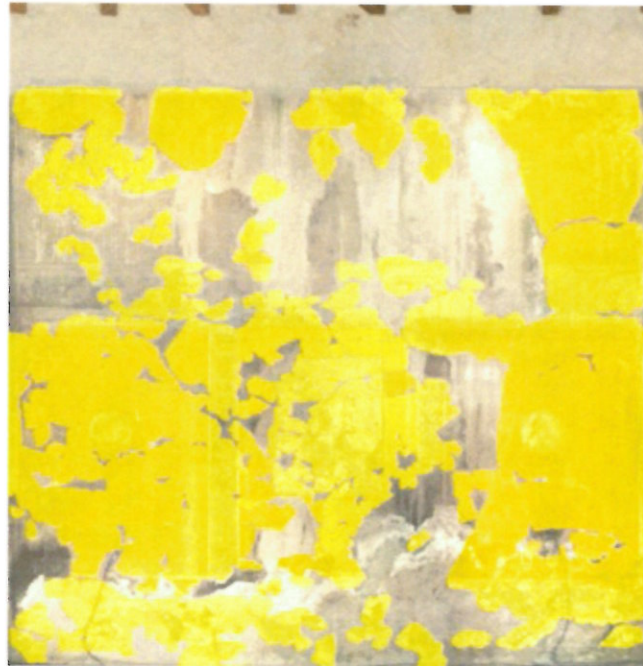
**FIGURE 2.5.**  
East wall. Yellow shading indicates  
original Roman plasters.

The east wall retains less original plaster than the other two walls, with the most severe losses in the upper register (approx. 70%) and the monochrome background of the middle of the lower register (fig. 2.5). About half the plaster is missing from the base of the wall.

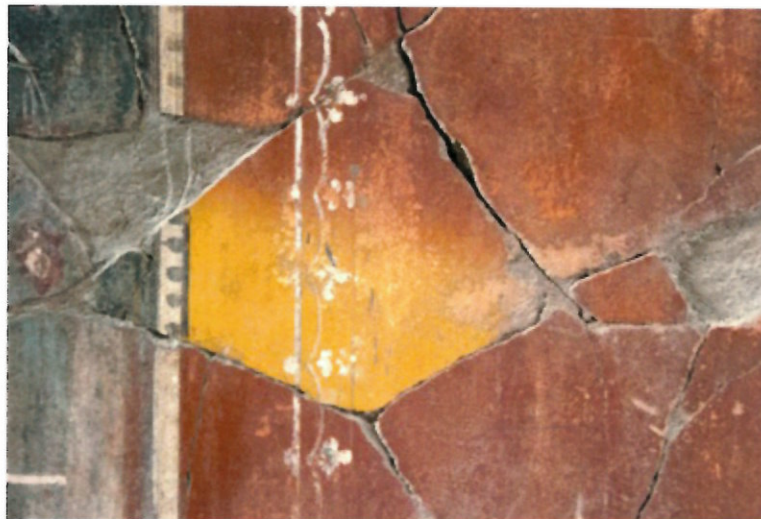
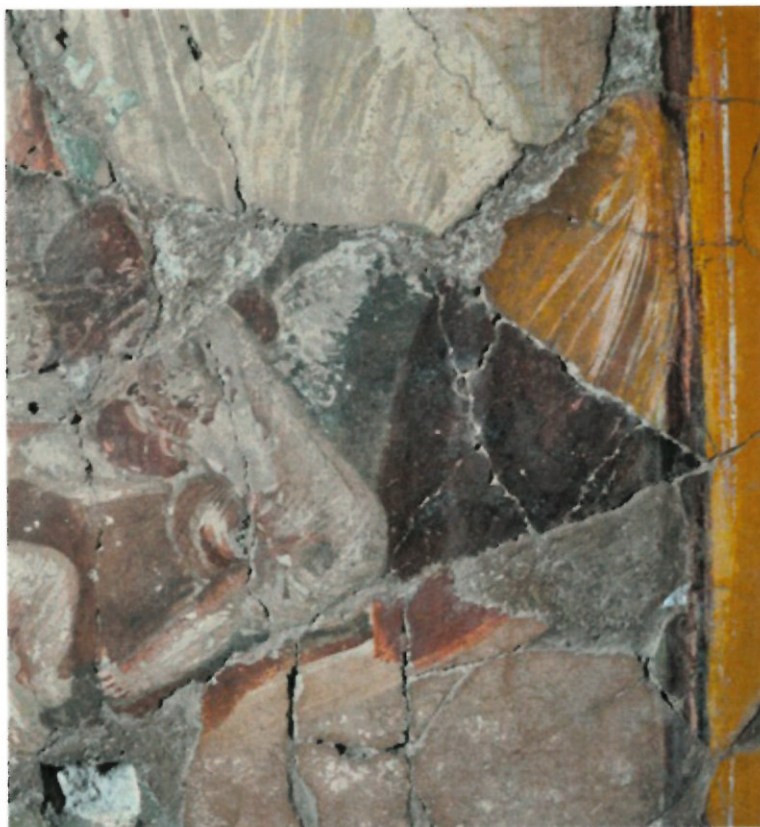
**FIGURE 2.6.**  
East wall. A fragment with yellow  
goethite pigment adjoins other frag-  
ments where the pigment has been  
transformed into red hematite.

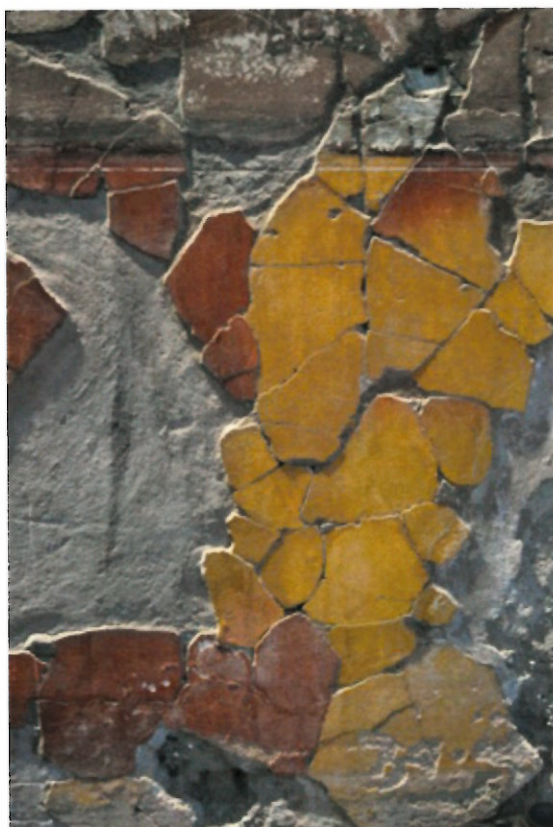
**FIGURE 2.7.**  
East wall. In the central scene, the same piece of drapery is yellow on one fragment, brown on another, and red on another.

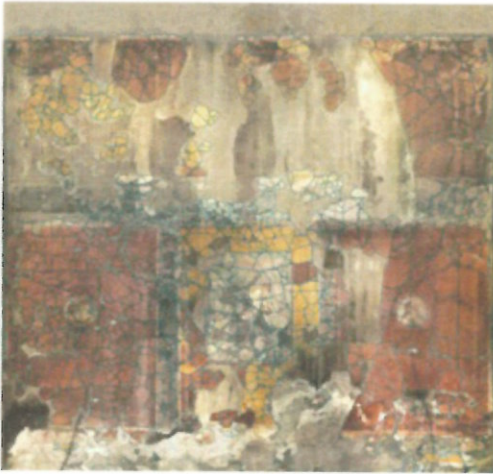
**FIGURE 2.8.**  
East wall. Lower register (raking light), showing principally yellow fragments somewhat irregularly fitted together.

The reconstruction of fragmented wall paintings is especially difficult when the fragments do not contain parts of an image or decorative elements as a guide and when pieces do not have clear, well-defined edges. This may explain why the surviving remounted parts of this section of the wall generally consist of fairly large pieces from the figurative scene and its borders, whereas the surrounding areas, which would have consisted principally of monochrome background with few distinctive graphic elements, have been left largely unreconstructed. The only significant monochrome area that is reconstructed at the center of the register is made up of yellow fragments (fig. 2.8).

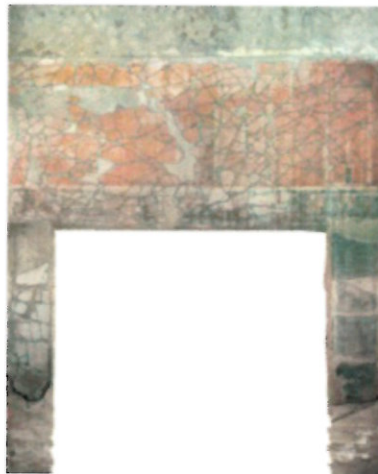
**FIGURE 2.9.**  
East wall. Map of fragments.

On the other hand, the plaster along the southern edge of the east wall (fig. 2.9) is made up on the whole of quite large fragments that fit closely together. This, together with the reasonably good condition of the corresponding wall in ambiente 9 (see fig. 2.4), suggests that the plasters here may have still been in place at the time of excavation and been in whole or in part detached and remounted, as evidenced by the pattern of cracking and fragmentation.

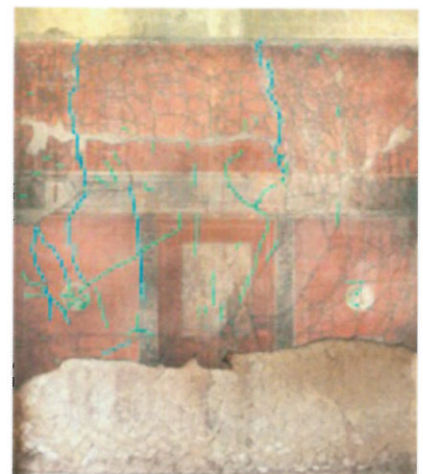
**FIGURE 2.10.**  
South wall. Map of fragments.

The upper register of the south wall (fig. 2.10) is principally composed of medium to large fragments, the western half and the underlying frieze for the most part fitting closely together. The eastern third is instead composed of a much more loose-fitting group of fragments surrounded by a large loss, suggesting perhaps that these were more damaged and detached than fragments in the western part. Although (like the west wall) the monochrome background in the upper register is now entirely red, it is likely the original color scheme incorporated yellow (like the east wall), but here all the original yellow goethite has been converted to red hematite. This suggests that no fragments were protected from the heat of the eruption, and may imply that fewer fragments fell off this wall and were buried.

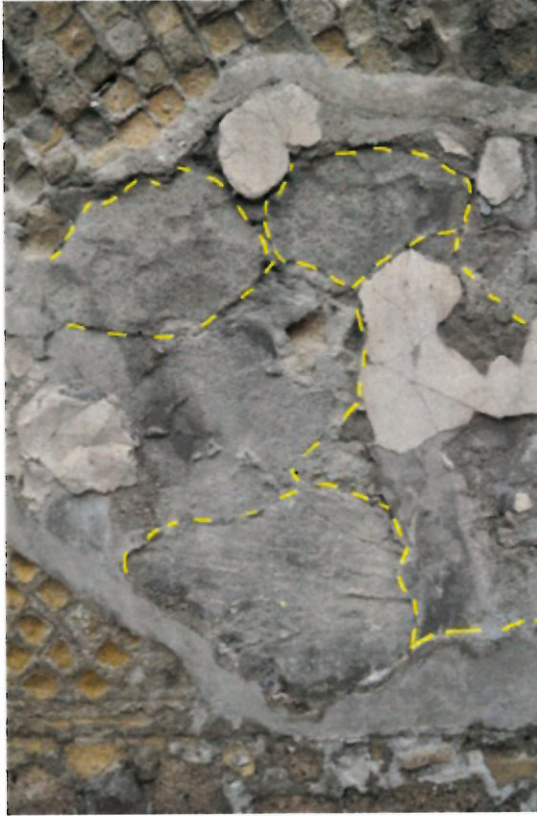
**FIGURE 2.13.** A remounted section of plaster from another area of the site that has lost almost all the Roman plaster, exposing the backing plaster and leaving an imprint of the original Roman plaster fragment (shown by the yellow dashed line).

Once set, this formed a rigid support, holding the pieces together in an "island," which could then be attached to the wall. Traces of backing plaster can be seen in examples of deteriorated wall paintings at the site, which have left this layer exposed (fig. 2.13).

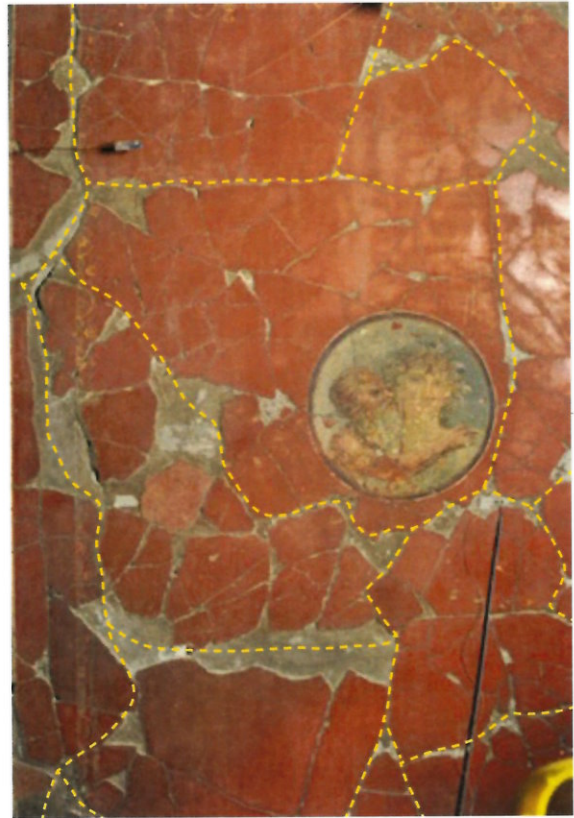
**FIGURE 2.14.** Areas of close-fitting pieces on the east wall that likely make up fragment islands, outlined in yellow.

**FIGURE 2.15.** Cement plugs that have formed around a fragment.

These islands frequently have small losses or gaps between fragments. In some cases, the backing plaster seeped into small cracks or gaps between fragments to form flat cement plugs at the level of the paint layer. In some areas of remounted plaster, there are many of these plugs (fig. 2.15).

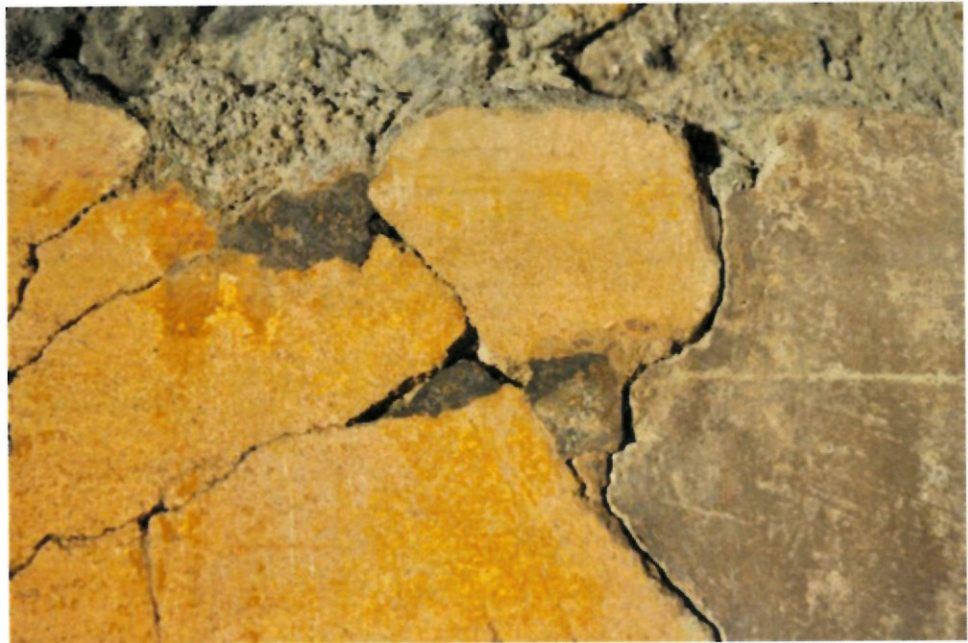
**FIGURE 2.16.**

Tablinum, south wall. A loss in the middle of a recomposed fragment island. Water damage has eroded the upper fill, exposing the underlying dark-gray backing plaster holding the separate surrounding fragments together, seen in the area inside the yellow dashed line.

In general, Maiuri's team did not fill any losses in the plaster up to the level of the paint, preferring to fill them 2–3 mm lower than the paint surface (fig. 2.16). They must have used a system to avoid the cement backing plaster from flowing through to the level of the paint

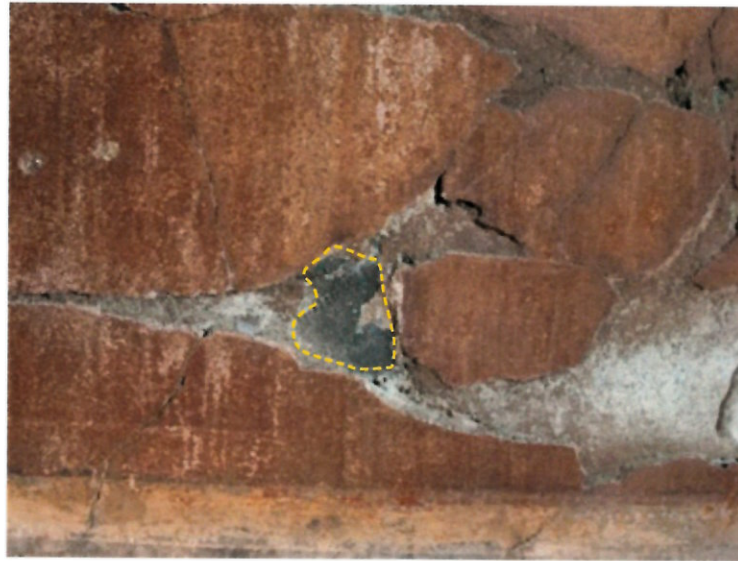
**FIGURE 2.17.**  
A hypothetical system for remounting fragment islands on walls.

An anchoring mortar, very similar in appearance and composition to the backing plaster, would have been applied to the wall to adhere the recomposed fragments. The island of fragments assembled on the backing plaster would have been positioned on the wall at that point and held in place by metal pins inserted into the wall along the edge of the fragments until the anchoring mortar had set (fig. 2.17). Clear traces of this anchoring mortar can be seen where it has splashed onto the tuff walls above the upper border of the plasters (fig. 2.18). It is likely the pins were removed or cut where possible once the anchoring mortar had set (fig. 2.19).

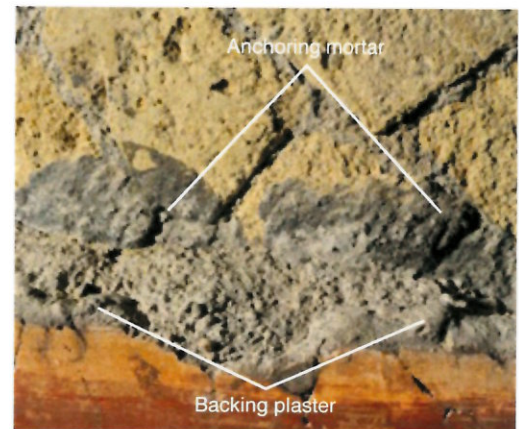
**FIGURE 2.19.**

Anchoring mortar around the edge of a piece of exposed backing plaster that has lost the original Roman plasters. The holes indicate the locations of pins that may have been removed once the anchoring mortar had set.

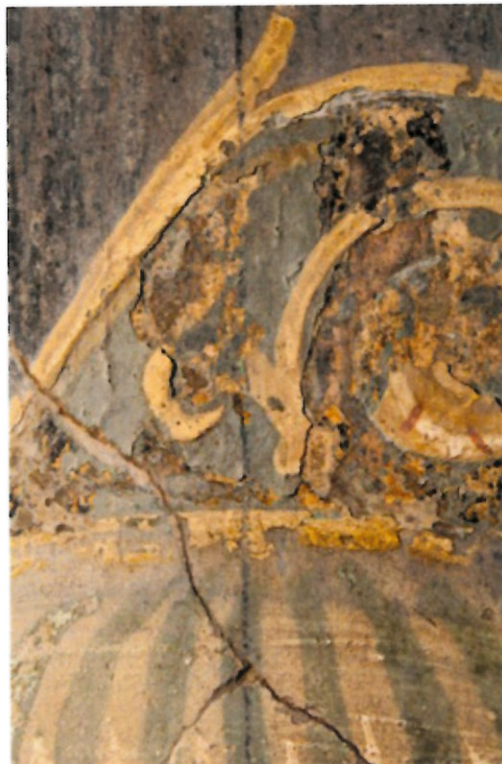
FIGURE 2.23.

The layers of restoration fills in losses in the original wall paintings on the south and west walls.

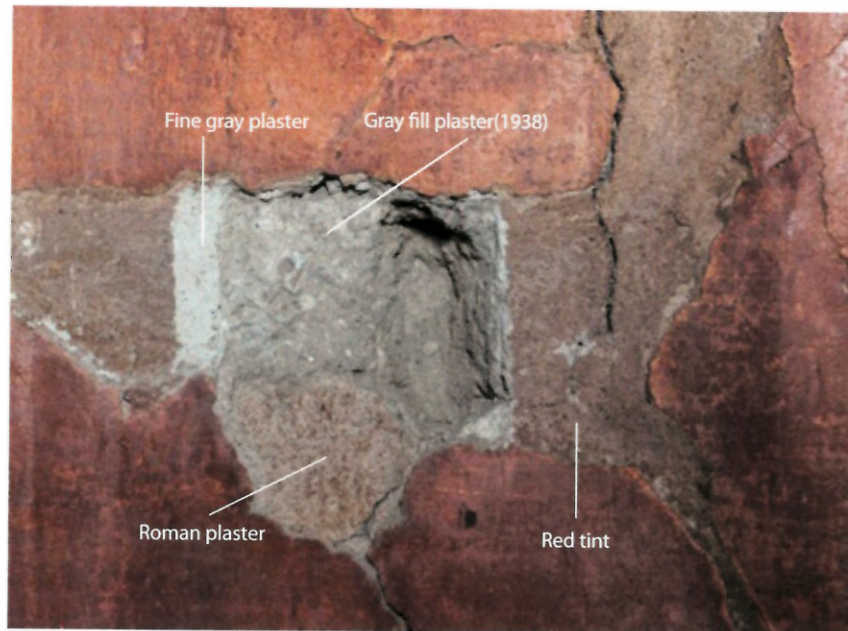
FIGURE 2.24.

Example from another area at the site, showing the different approaches used by Maiuri for the treatment of major lacunae: losses between islands of Roman plaster are filled with a gray lime-wash plaster with connecting design elements sketched in by white incisions. Instead, where there are no connecting islands, the walls are left as bare tuff (mostly modern) (Casa del Bel Cortile, Herculaneum).

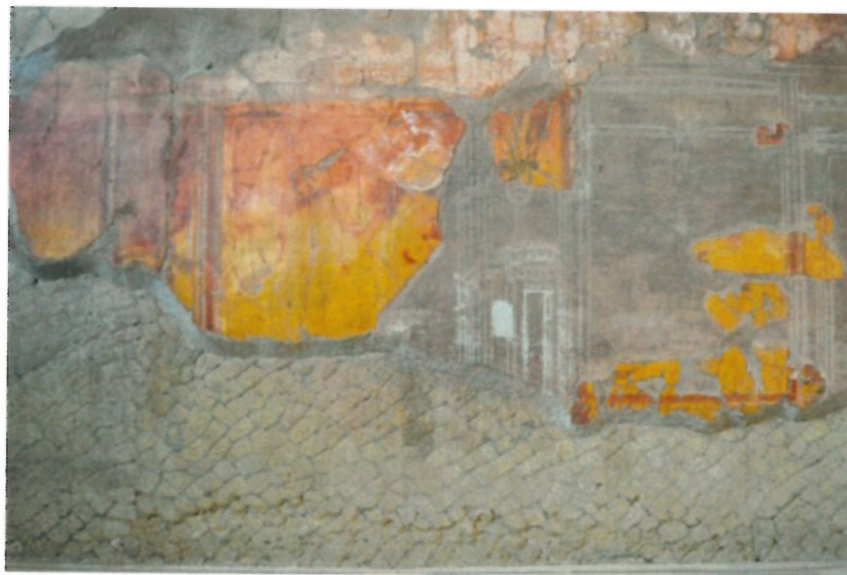
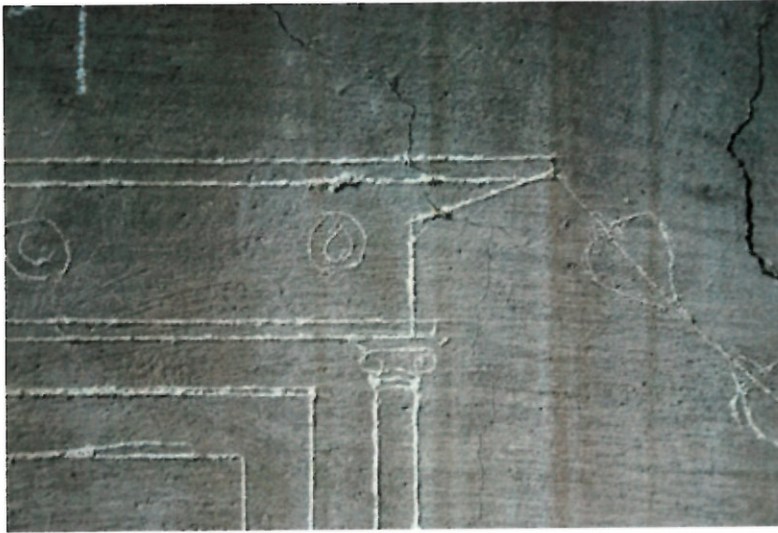
**FIGURE 2.25.** Reconstruction of the basic design of architectural elements on the upper east wall by Maiuri's team in area of large loss made by incising a line through a gray lime wash applied to the surface to reveal the thinly applied fine white lime plaster below.

large areas of loss, it was covered with a thin (1–2 mm) white plaster layer. This, in turn, was covered with a coat of gray-tinted lime wash. The line drawings re-creating the outlines of the decorations were then incised in the surfaces, breaking through the gray covering tint and exposing the white plaster underneath. This created an effect of white lines on a gray background (figs. 2.25–2.26).

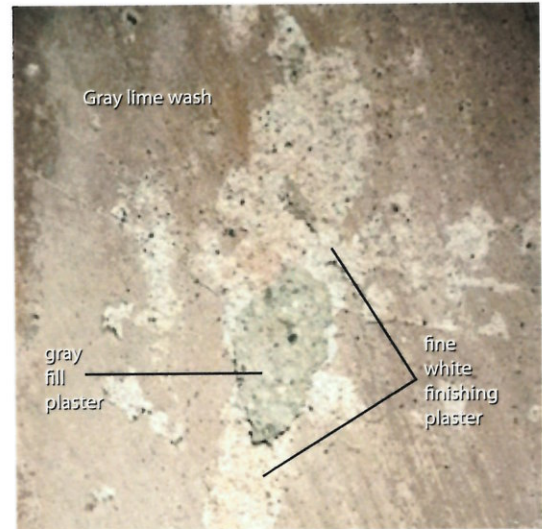
**FIGURE 2.26.** Flaking paint and plaster expose the stratigraphy of the reconstruction plaster in a loss on the east wall: gray lime wash over a thin white plaster covering a thick layer of gray fill plaster.

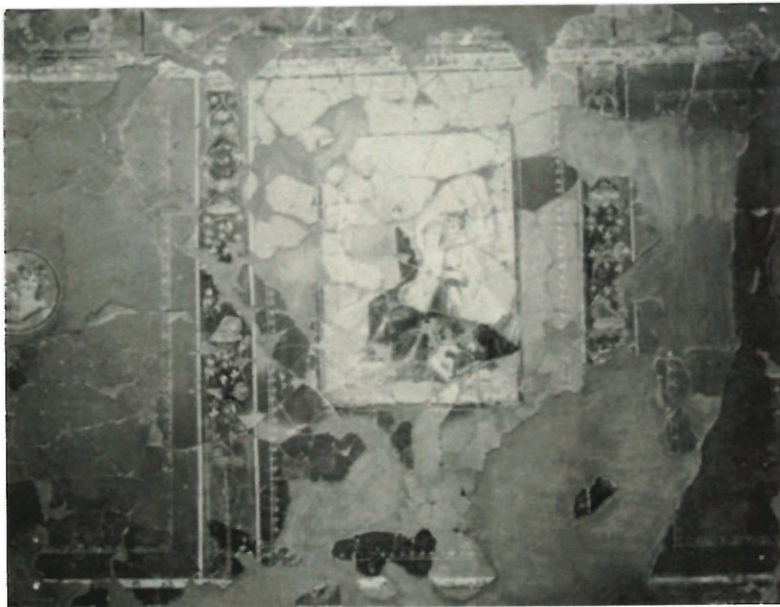
**FIGURE 2.27.** Central section, east wall, 1938, just after restoration and before the *sgraffito* design was incised in the reconstruction plaster surrounding the original fragments. (Historical Archives of the Soprintendenza Pompei, Maiuri, C2782)

This technique is seen in two historical photographs of the east wall that show the wall paintings during reconstruction in 1938 with a large fill (fig. 2.27) surrounding original plaster fragments and the central rectangular scene and, much later, in 1983, with the incised *sgraffito* design (fig. 2.28).

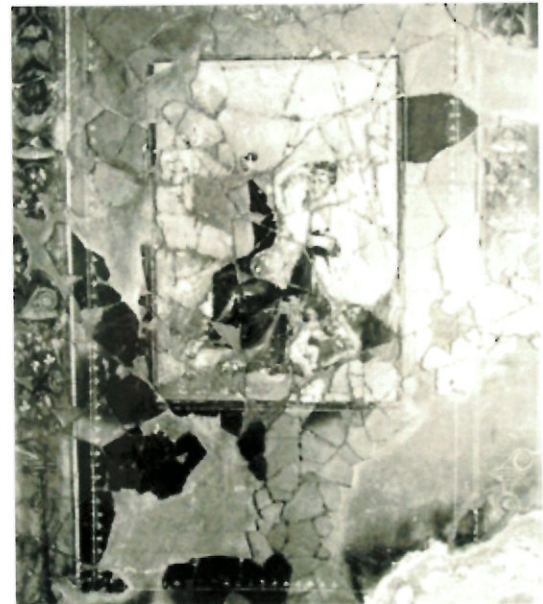
**FIGURE 2.28 (RIGHT).** Central section, east wall, 1983, showing the *sgraffito* design in the reconstruction plaster surrounding the central rectangular scene. (Historical Archives of the Soprintendenza Pompei, Maiuri, D29302)

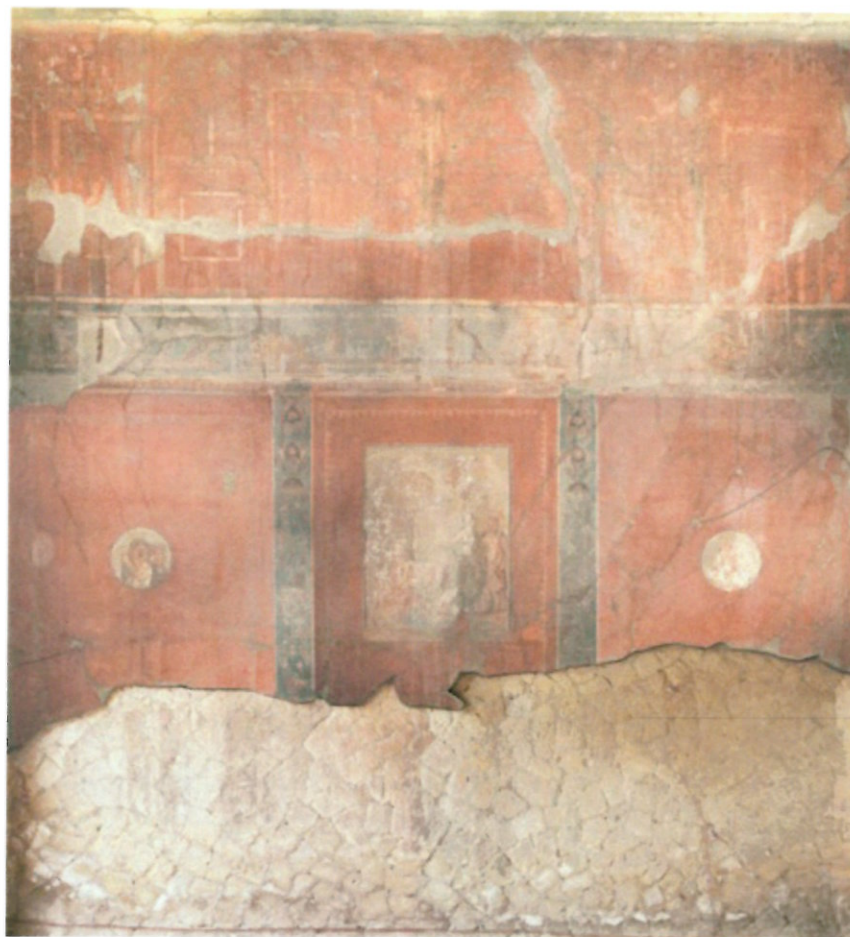
**FIGURE 2.29.**

Overall of west wall of the tablinum, showing the approach used by Maiuri for the treatment of major lacunae with no fragment islands, leaving the bare tuff (mostly modern) along the base of the wall.

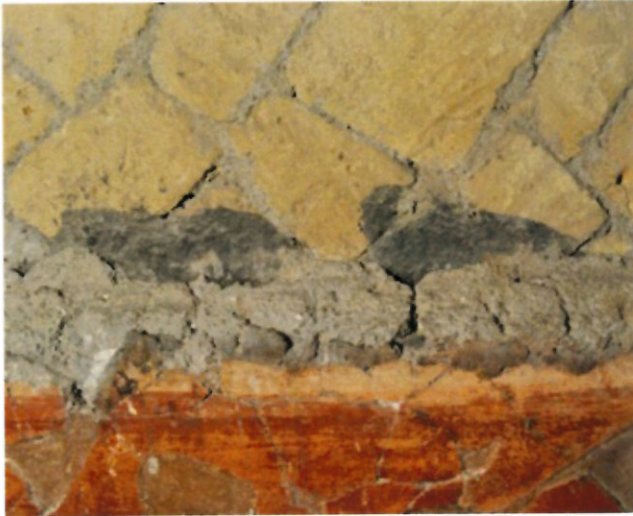
**FIGURE 2.30.**  
Coarse-grained mortar edging partially covering both anchoring mortar and backing plaster.

On both the upper and lower borders of the original and reconstructed plasters, where bare tuff wall begins, a sloped edging plaster was applied. Some of the plaster strip along the upper border has remained in situ and appears to be similar to the rough fill (fig. 2.30).

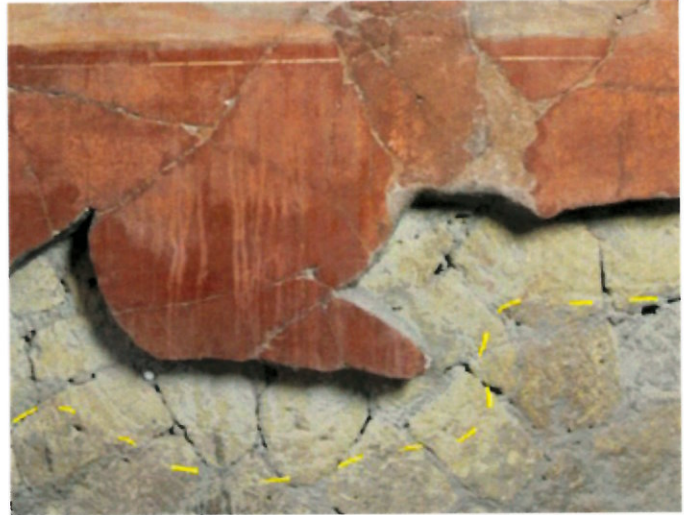
**FIGURE 2.31.**  
Lower edge, west wall. The lighter-colored strip (outlined by the yellow dashed line) is the location of the first sloped edging plaster.

Along the lower edge of the west wall, all of the 1938 edging plaster was removed in a subsequent treatment and was replaced with plaster borders perpendicular to the wall plane. However, the location of the original mortar edging can still be clearly seen as a lighter-colored strip on the tuff wall extending the length of the lower border (fig. 2.31).
