# A ROCK CHURCH PREVENTIVE CONSERVATION PROJECT: THE CASE STUDY OF THE CRYPT OF ONE HUNDRED SAINTS IN MATERA

**Abstract** - The church of the Hundred Saints, now better known as the Crypt of the Original Sin, is located in the gorge “*Gravina di Picciano*”, about ten kilometers from Matera. The rock church and its decorations, dated back to the ninth century, were in critical condition when it was discovered and later acquired by the Zetema Foundation of Matera. In 2000, a monitoring project was started under the scientific direction of Michele D'Elia, and is still ongoing in collaboration with specialists from the ICR (now ISCR), from UniromaTre, and various technical experts. The project aimed to design a conservation plan and to find solutions not only for the specific problems, but also to develop a protocol for the conservation and maintenance of similar rock-art sites. The wall paintings were colonized by different microorganisms and showed problems of salt efflorescence and carbonation. A program was set up to control bio-growth, carry out characterization of materials, test treatment products and perform interventions to resolve the site's conservation problems. After conc

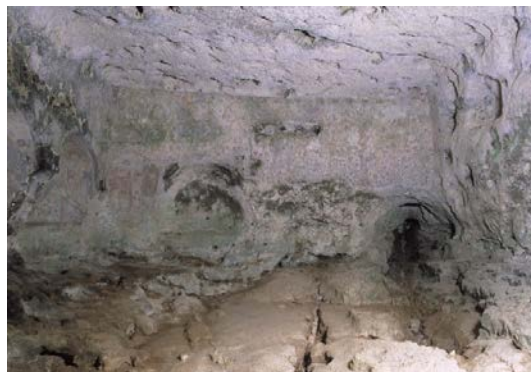
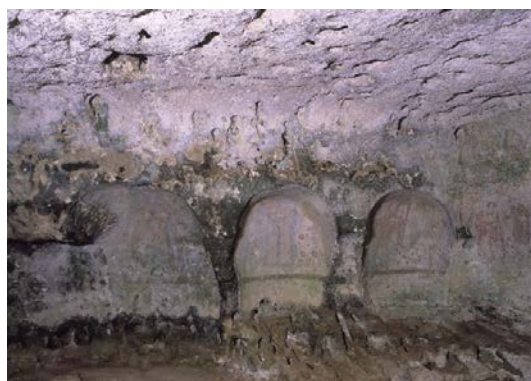
The rock church, was discovered in 1963 by the *Circolo La Scaletta* of Matera. The paintings, dated to between the second half of the 8th and the 10th centuries, are found only on two walls of the principal space: wall A (Fig. 1a, in 2003), parallel to the gorge, and wall B (Fig. 1b, in 2003) perpendicular to it.

Fig.1a, b Wall A and B in 2003, before treatment

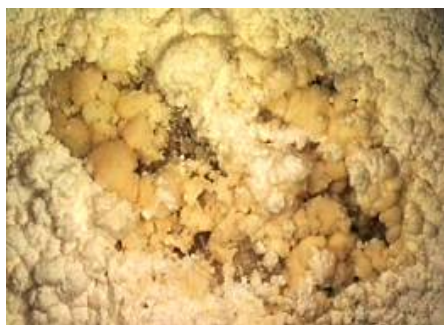
In the same campaign, chemical degradation phenomena were also analyzed. These were above all salt efflorescence – essentially calcite and gypsum – in the form of either white veils on the paint layers, or, where there were losses in the plaster, generally thicker encrustations with at times spherical formations (Fig. 2), orangish in colour (Caneva and Pacini 2002-3; Giovagnoli et al, 2005).

Fig. 2 Spherical formations due to salt efflorescence.

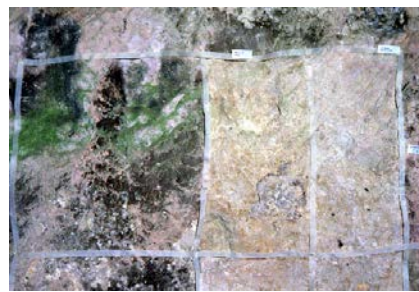
To address the treatment of biodeterioration phenomena, tests were carried out to choose between three different biocides at two different concentrations: Rocima 110 (Acima), a quaternary ammonium salt + tin naphthenate; Preventol R80 (Bayer) benzalkonium chloride; Umonium 38 (Huckert's International) benzalkonium chloride + alcohols. Evaluation of results included observation under UV (Wood's lamp) and fluorescence (Figs 3a and 3b).

Fig.3a and b Biocide test using natural light and UV light

The biocide chosen was mixed in distilled water at 2% concentration and was applied by brush on the painted layer, and by brush and by spray (at 1.2 atmospheres) over the entire crypt; we tried to reach, as far as possible, to the bottom of all the deepest cavities of the stone, including the karstic cave on the right of the wall A.

During testing, none of the three biocides examined caused color changes to the surface and while both Preventol R80 and Rocima 110 (at 2% in deionized water) were effective against the microflora, the former proved more efficient. Consequently, the first treatment of the biological patinas was carried out with Preventol R80 in November 2003, as previously described. Higher plant removal was limited to the large fig (*Ficus carica* L.) near the entrance cave with satisfactory results.

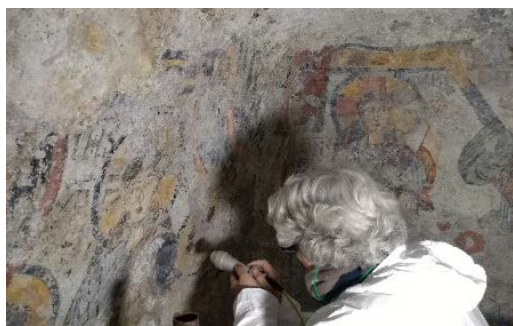
Fig. 4 Cleaning with EOS 1000 LQS laser

In the last phase of the intervention, laser cleaning was tested for the removal of white salt veils. These tests employed a EOS 1000 LQS laser at 380mJ with an impulse frequency of 10Hz, and 6mm spot. Trials were also performed with the THUNDER COMPACT laser.

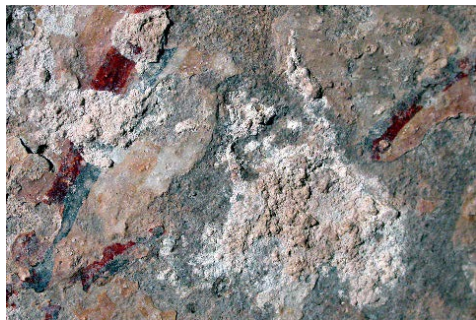
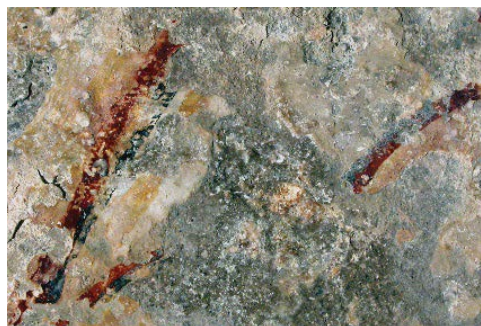
Fig.5 a and b Carbonate deposits before and after removal.

Removal of carbonate deposits was carried out with electric micro-drills (Proxxon) with various different tips (abrasive, diamond, synthetic brushes of various hardness). For final cleaning of carbonate veils two types of cationic exchange resins produced by PHASE were tested. The first was the commercially available Descalbante 90, which was composed of the ionic exchange resin plus supporting material. The second product was the ion exchange resin on its own, with no supporting material, and was not commercially available. Both products were mixed with deionized water and applied by brush and/or spatula.

Mechanical reduction of the thick carbonate deposits over the paint layer required the extreme care, as did removal of even thicker deposits in plaster losses. (Figs. 5a and 5b), Removal of the very thin white veils on the paint also produced good results.
